**CARNEBUCK
WIND FARM**
FIGURE 1.10
SITE ENTRANCE

LAYOUT DWG	N/A	T-LAYOUT NO.	N/A
DRAWING NUMBER	03090-RES-ACC-DR-LO-002	REV	2
SCALE - 1:1,500 @ A3			
ENVIRONMENTAL STATEMENT 2022

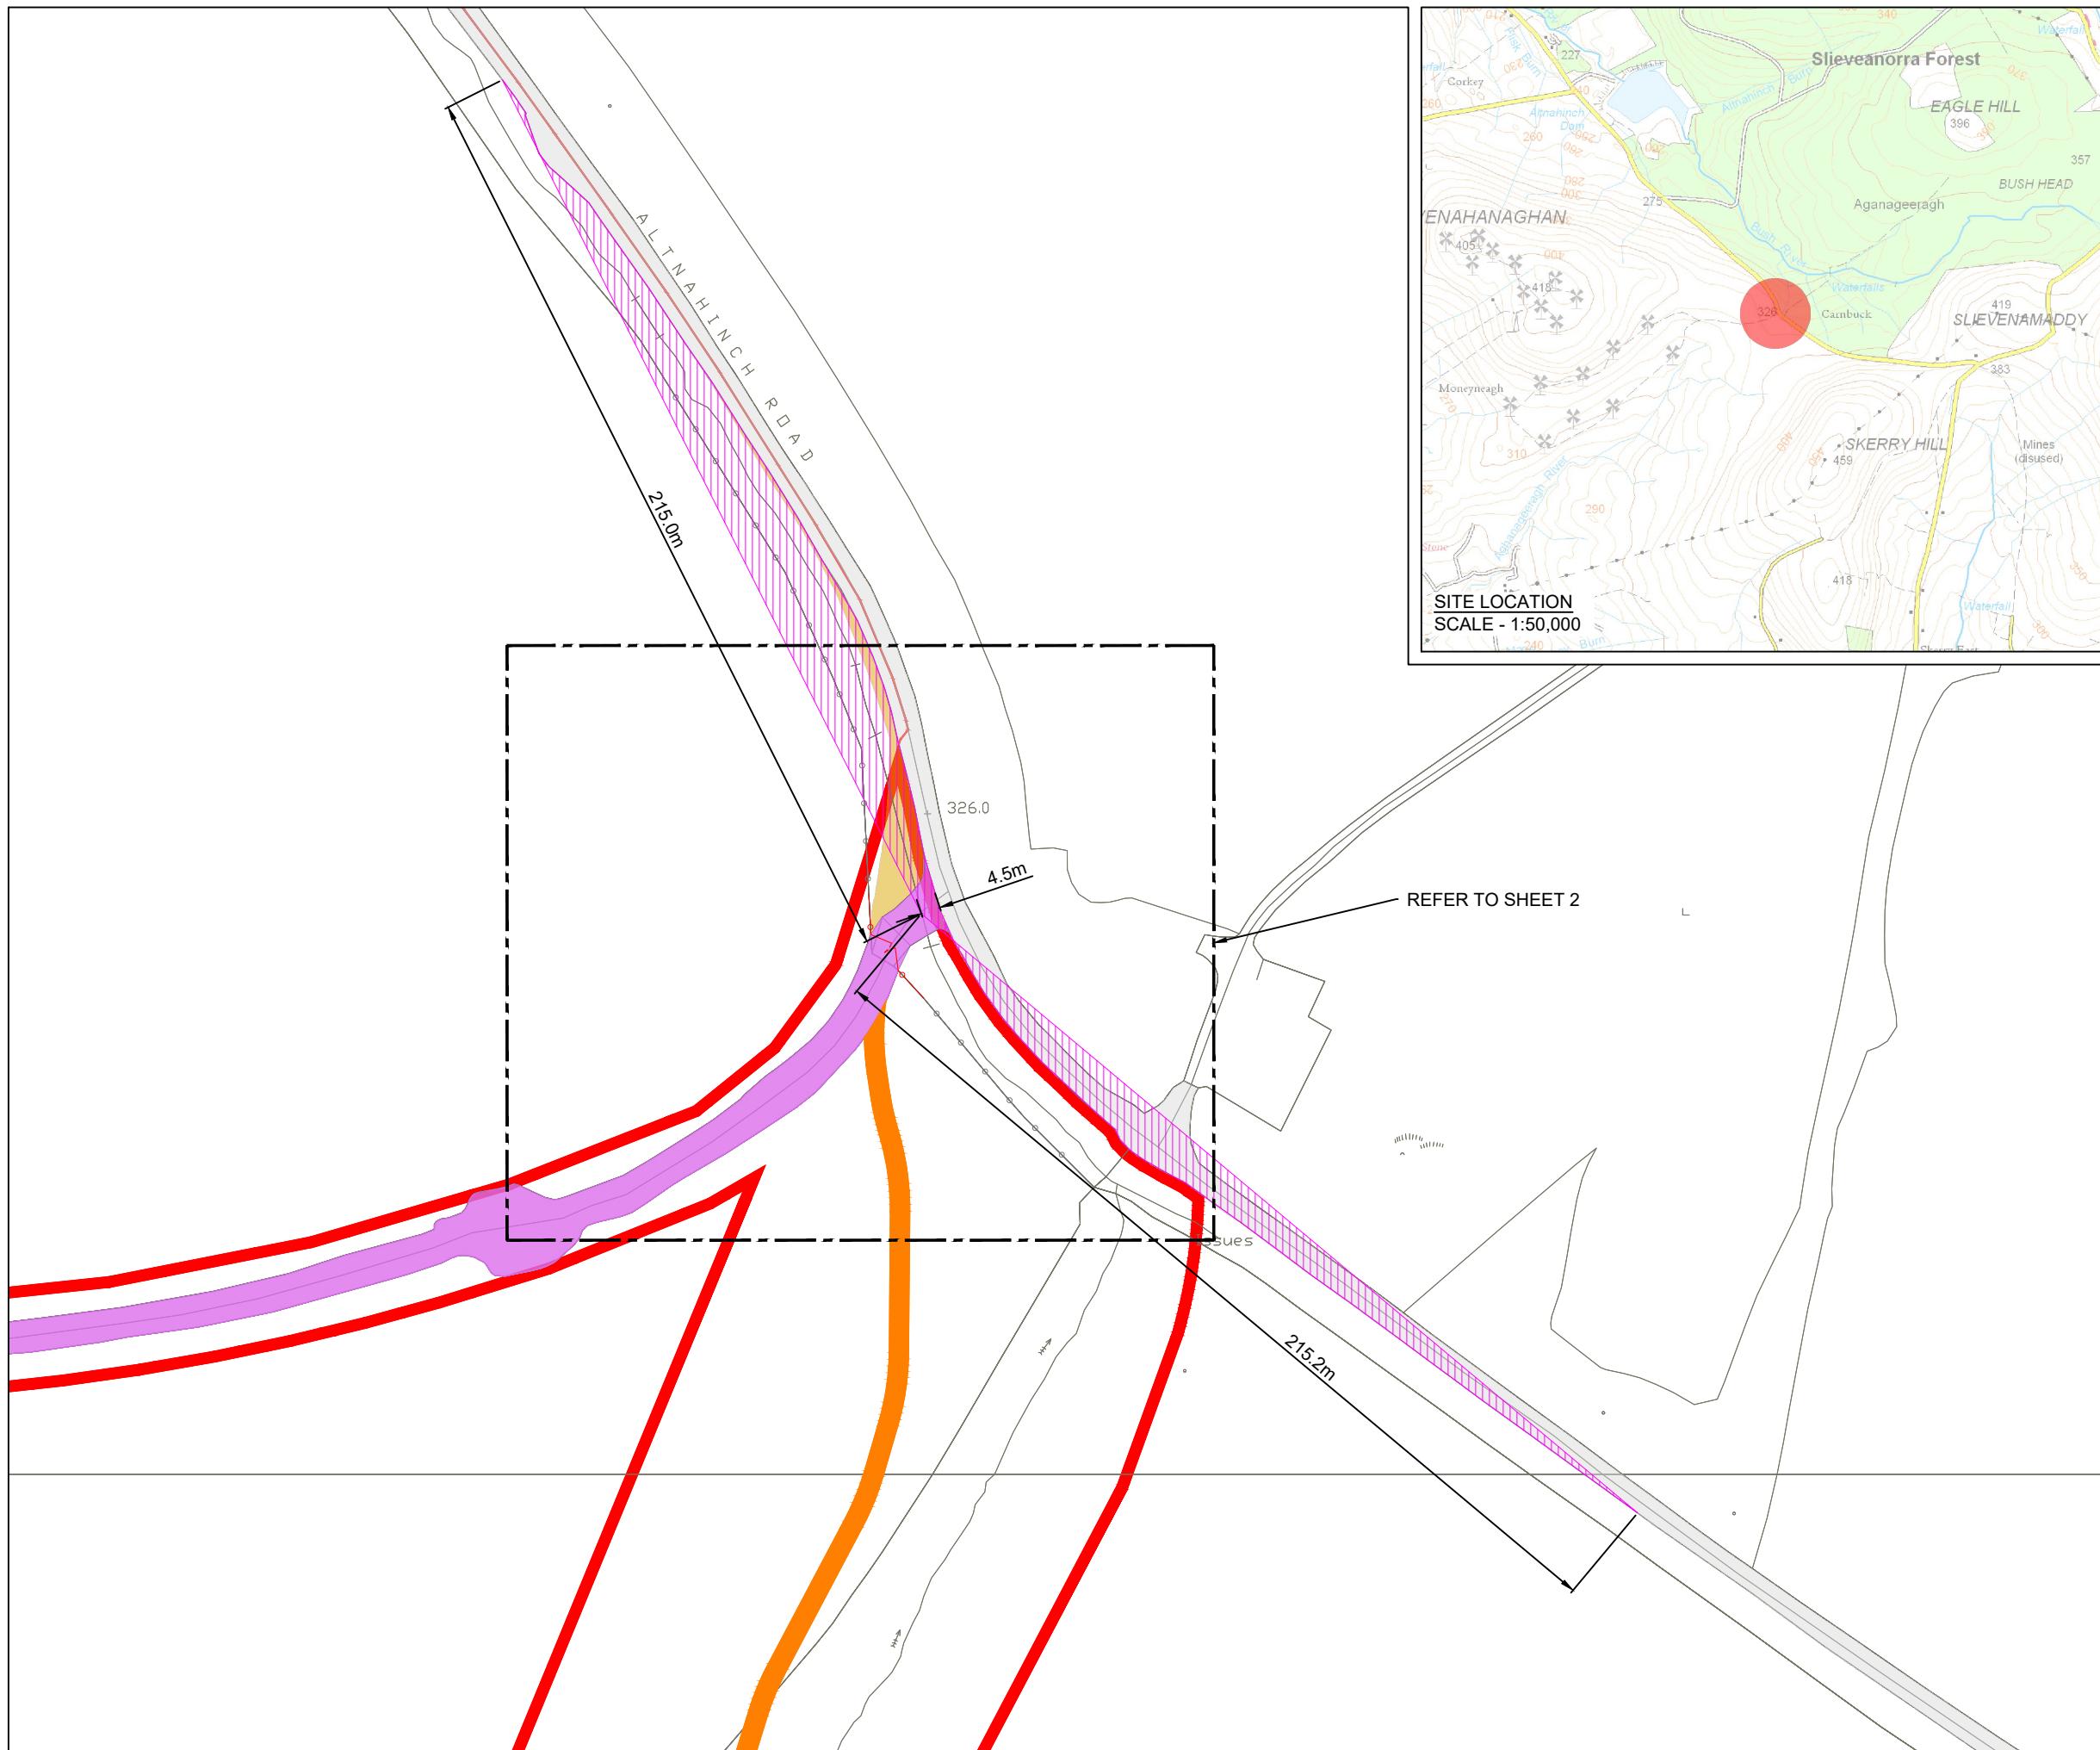
FIGURE 1.10

SITE ENTRANCE

PLANNING APPLICATION BOUNDARY &
VISIBILITY SPLAY OMITTED FOR CLARITY

PROPOSED TEMPORARY REMOVAL OF BOUNDARY
GATE & FENCE DURING TURBINE DELIVERY PHASE
